NPRF ADVISORY NOTE

Issued 2nd November 2009

Waterless Urinals

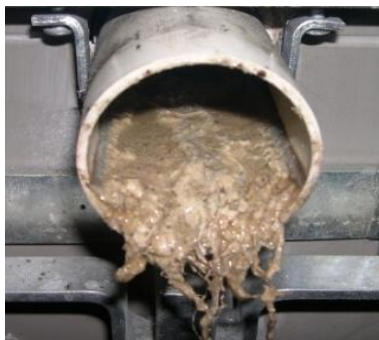
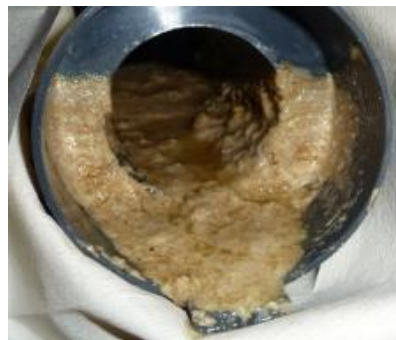
The above images show the build up of Struvite within 12 months of installation.

At this stage it is recommended that facility owners and managers arrange for waterless urinals be inspected and cleaned at periods of no less than 6 months, until a more appropriate maintenance interval can be established for each facility. The maintenance interval will be dependent on a number of factors such as usage patterns, waterless urinal type, drainage design and other factors.
